Bulletin No.: 08032A
Date: July 2008

CUSTOMER SATISFACTION PROGRAM

SUBJECT: Uneven Police Car Rear Tire Wear – Replace Rear Wheel Spindle Rods

MODELS: 2007-2008 Chevrolet Impala
Equipped with Police Package (RPO 9C1/9C3)

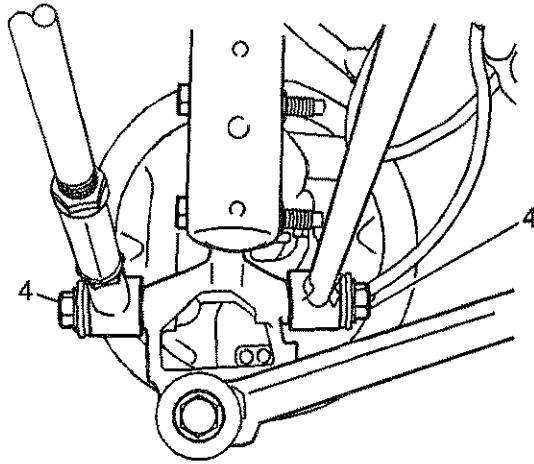
2129076

5. Remove the rear wheel spindle rod bolts (4) and nuts from the knuckles (both sides).
6. Remove the stabilizer shaft from the rear suspension support.
7. Support the rear suspension support with jack stands and remove the mounting bolts.
8. Lower the rear suspension support in order to gain access to the rear wheel spindle rod to support bolts.

15. Install the stabilizer shaft to the rear suspension support.
16. Install the rear wheel spindle rod bolts and nuts to the knuckles (both sides).

Tighten

Tighten the nuts to 150 N·m (110 lb ft).

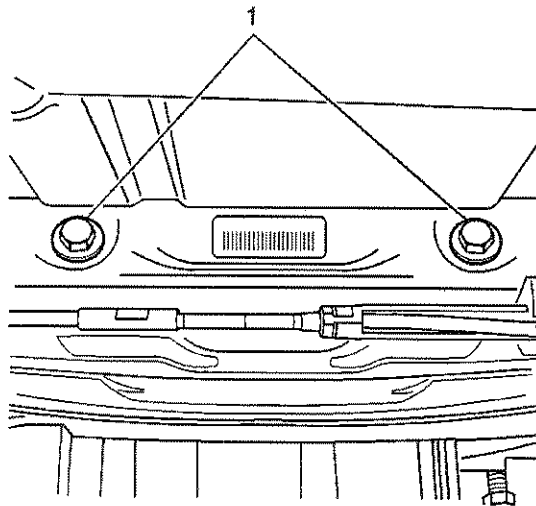
614974

9. Remove the four rear wheels spindle rod bolts (1) and nuts from the rear suspension support.
10. Remove the rear wheel spindle rods from the vehicle.
11. Install the new rear wheel spindle rods to the vehicle.

12. Install the four rear wheel spindle rod bolts and nuts to the rear suspension support.

Tighten

Tighten the bolts to 135 N·m (100 lb ft).
